ΓΕΦΥΡΑ ΡΙΟΥ-ΑΝΤΙΡΡΙΟΥ «ΧΑΡΙΛΑΟΣ ΤΡΙΚΟΥΠΗΣ»

Καινοτόμες Μέθοδοι Παρακολούθησης &
Συντήρησης Ειδικών Γεφυρών
Η Περίπτωση της Γέφυρας Ρίου-Αντιρρίου
«Χαρίλαος Τρικούπης»

Innovative Monitoring and Maintenance of
Major Bridges
The Rion-Antirion Bridge “Charilaos
Trikoupis” Case Study

RION – ANTIRION BRIDGE PROJECT DESCRIPTION (1/5)

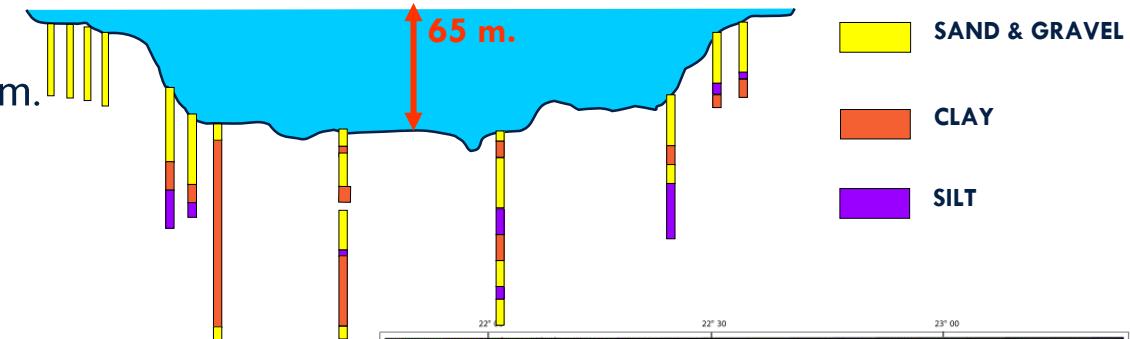
Weak Sea Bed

No bedrock encountered in first 100 m during soil investigations, while geological studies indicated similar conditions for up to 500 m.

Water depth up to 65 m

Uniform sea bed at depth of 60 m with steep slopes near coast.

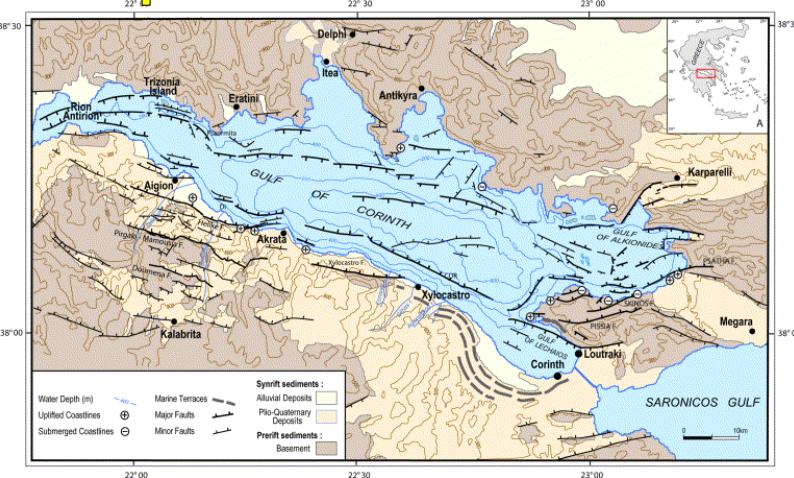
High Seismicity & Tectonic movements

Active normal faults on both sides of Corinthian gulf, at the vicinity of Bridge while the tectonic kinematic of area indicates separation of Peloponnese from mainland Greece with rate of ~15 mm/year.

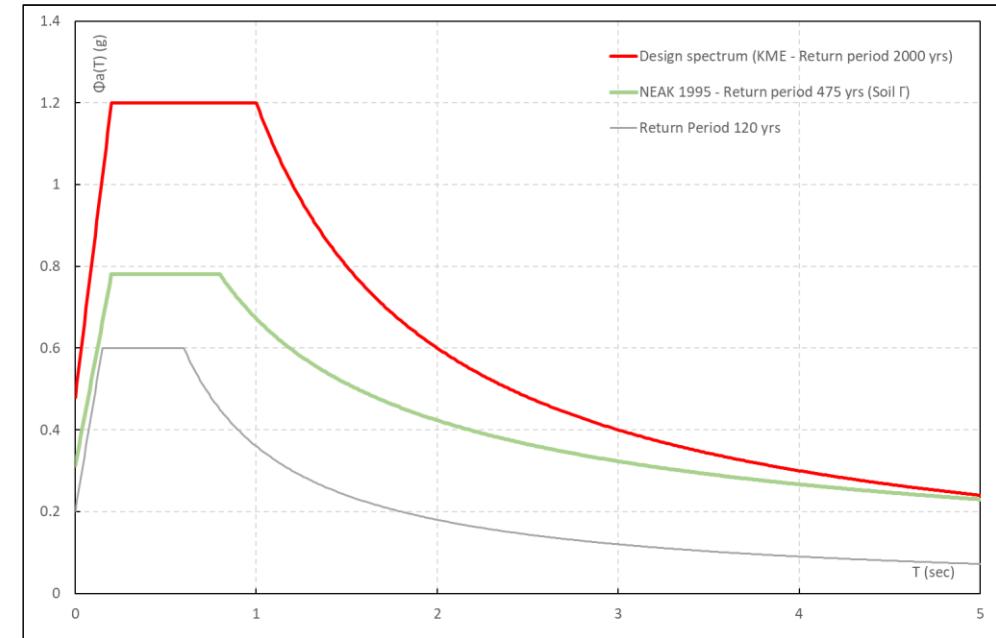
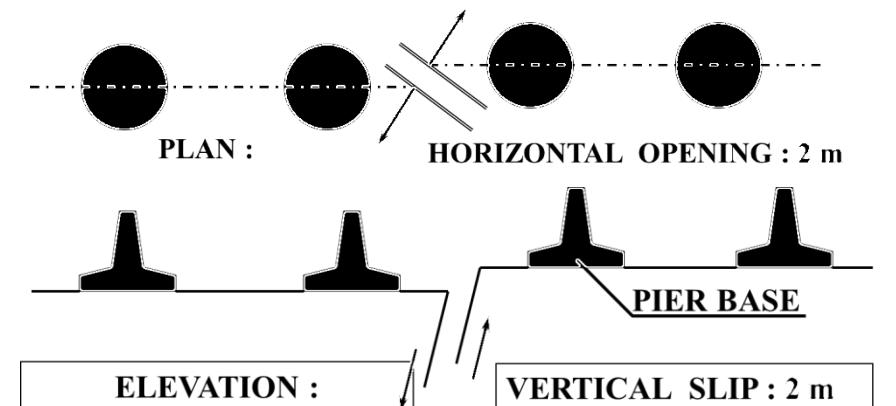
Structural Design -Design Loads & Requirements

Seismic loads

- Seismic design load (Spectrum: pga 0.48 g, max Sa 1.20 g for T=0.2 up to 1.0 sec) - EQ with 2000 years Return Period.
- Tectonic movements:
 - Up to 2m (between adjacent piers) as separate load
 - Up to 1m (between adjacent piers) when combined with specified EQ

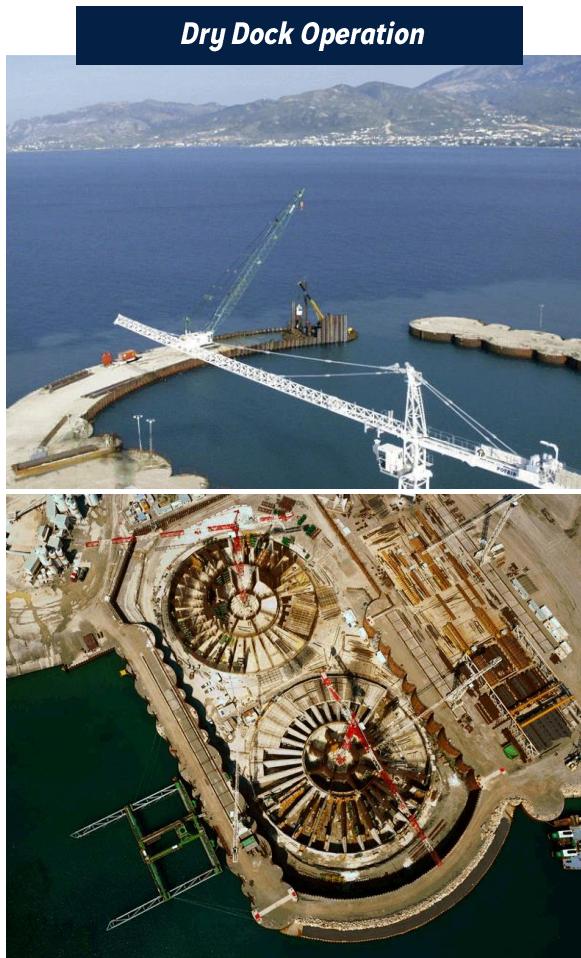
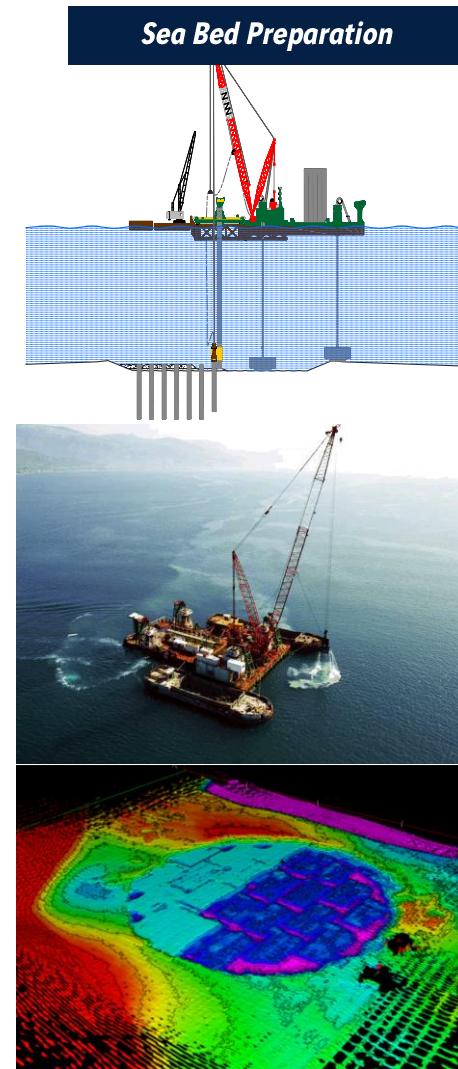
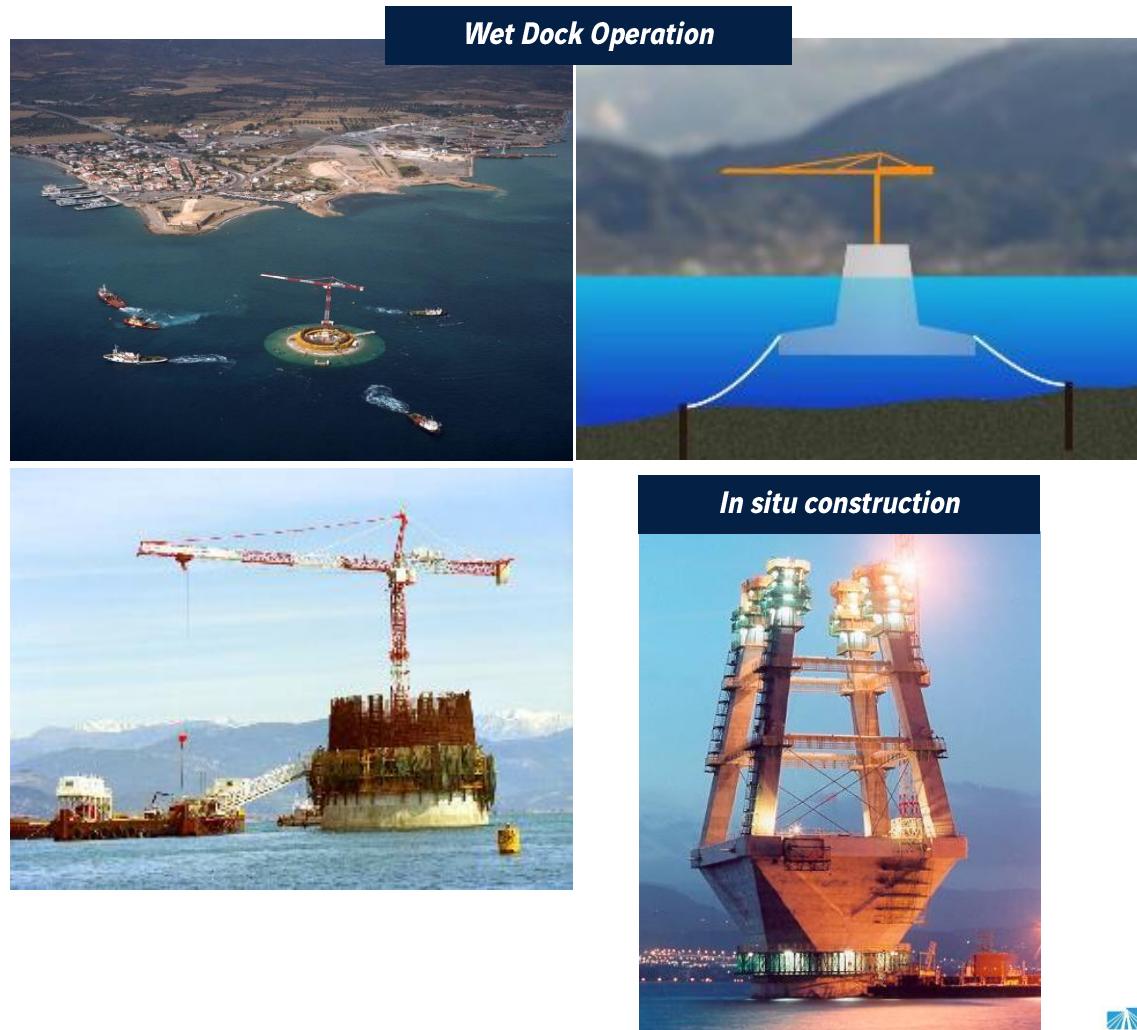
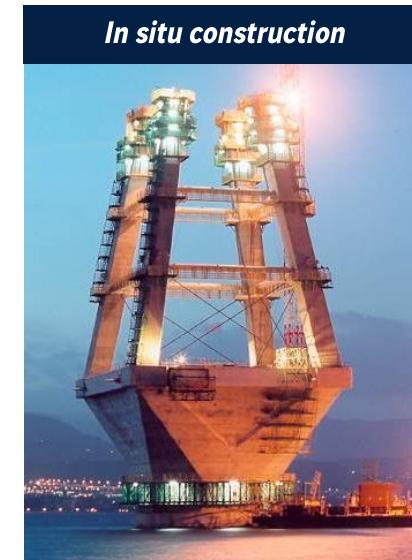
Main Bridge – Construction stages

RION – ANTIRION BRIDGE PROJECT DESCRIPTION (5/5)

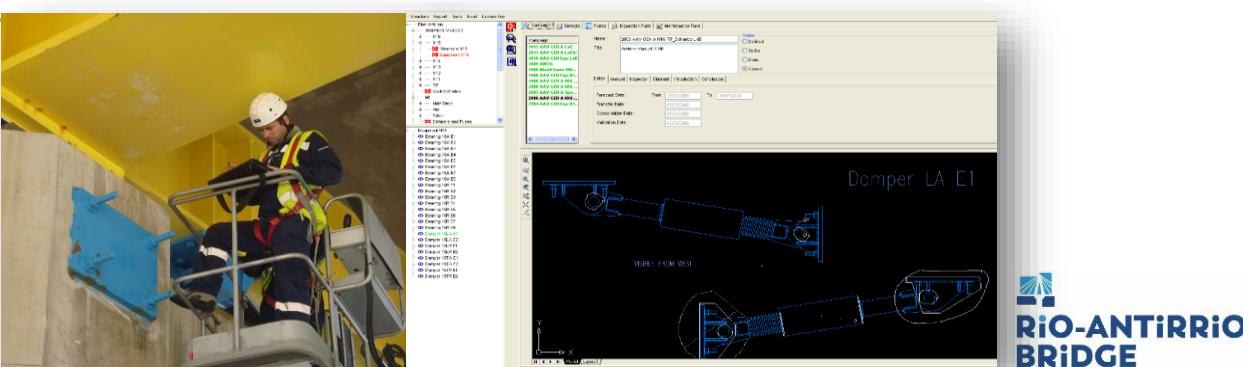
ASSET MANAGEMENT VISUAL & MATERIAL MONITORING: PROCESS OVERVIEW AND MAIN FEATURES

VM main features:

- Fully computerized inspections except for specialized means (rope, underwater, supplier)
- Defect Library set up in IMM & populated continuously
- Breakdown of structures into simple elements (5713)
- Simplified ASB drawings for finding location & developed views of all surfaces
- More than 110 types of inspection forms
- >95.000 photos since 2004

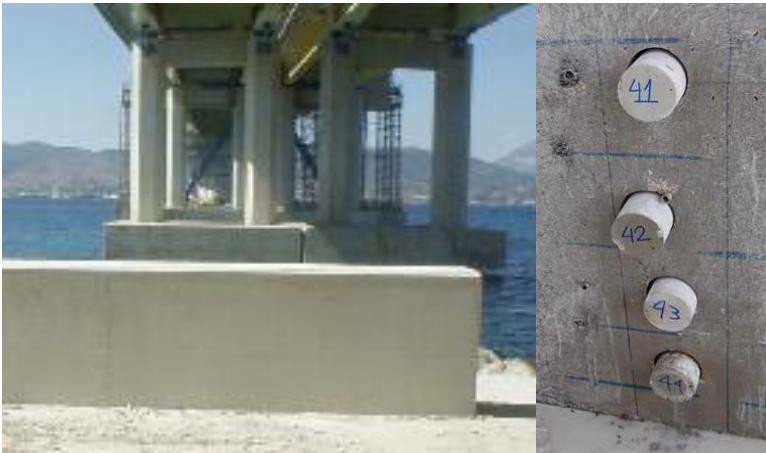
Material Monitoring: Concrete Durability

Sacrificial concrete block at P2 of Rion Approach Viaduct for concrete durability monitoring

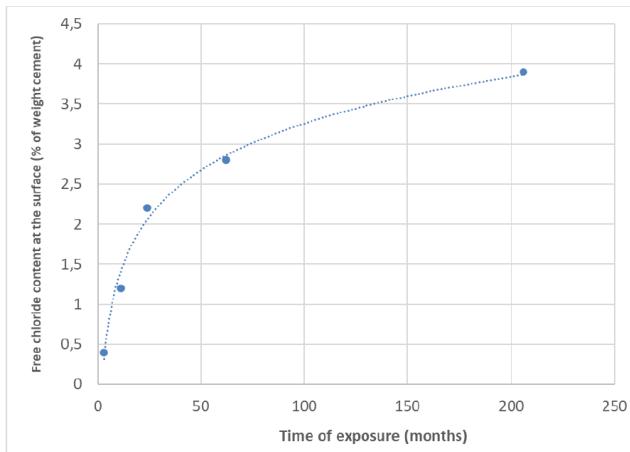
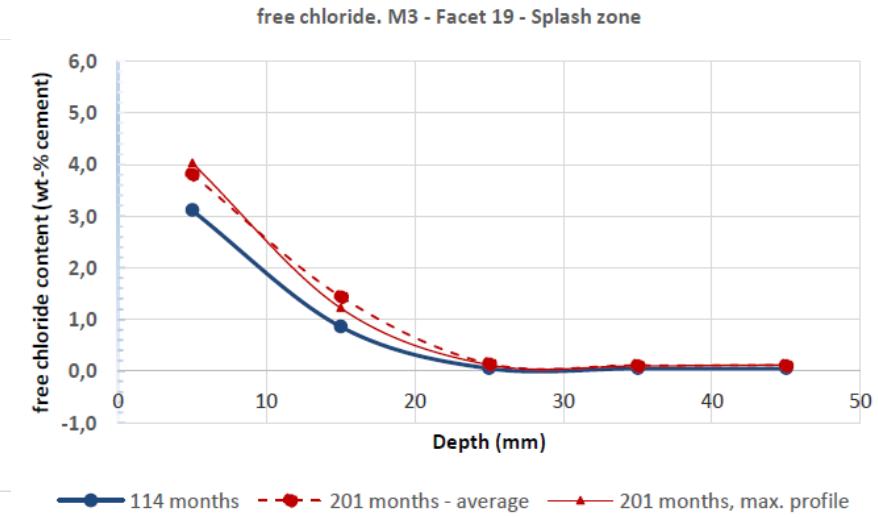
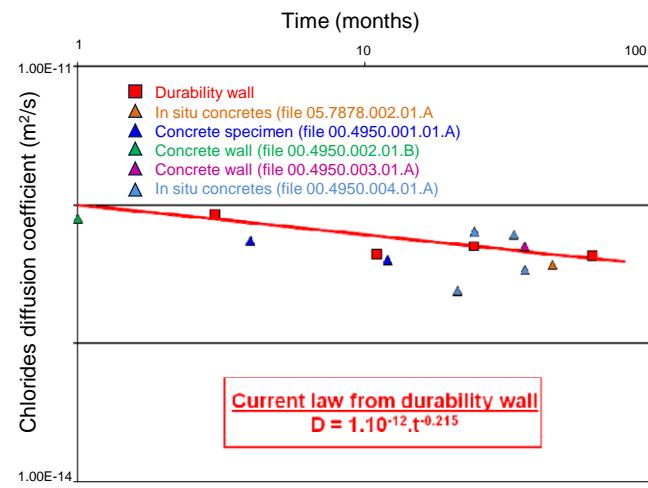
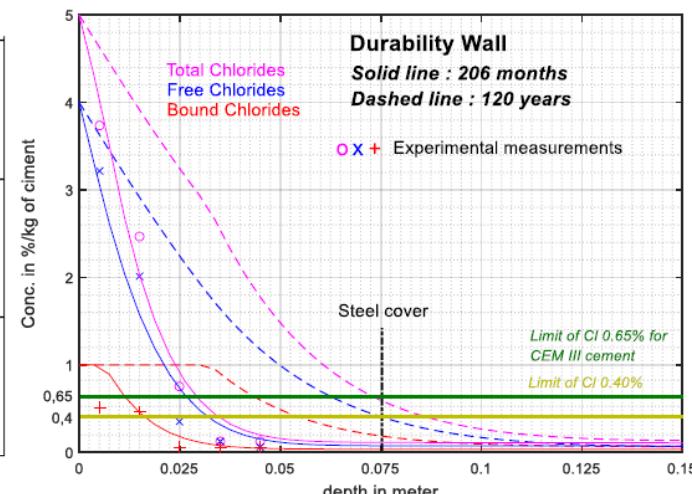
- Measurement of total and free chlorides contents as a function of the depth (from the face of the concrete to 80mm).
- Determination of the chloride diffusion coefficient.
- Life cycle assessment: Simulation through LERM model to assess the free chlorides content at 75mm depth at 120 years.

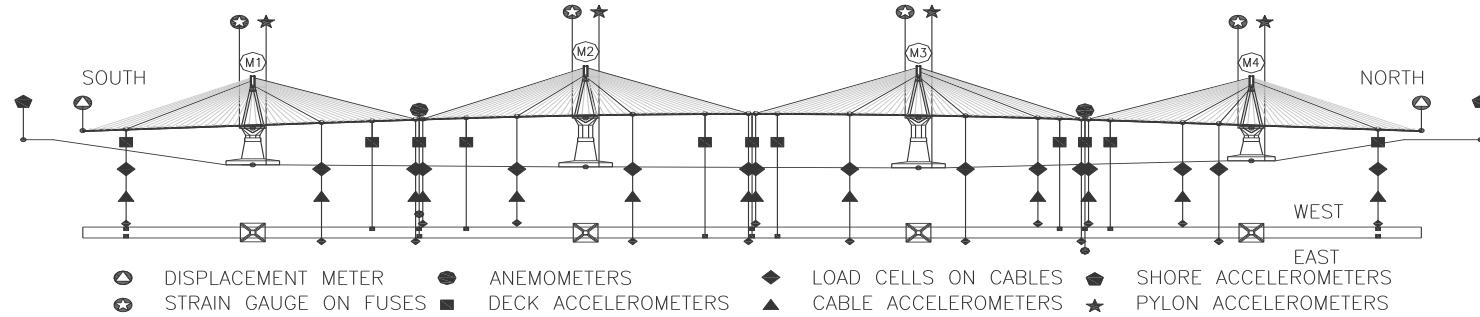
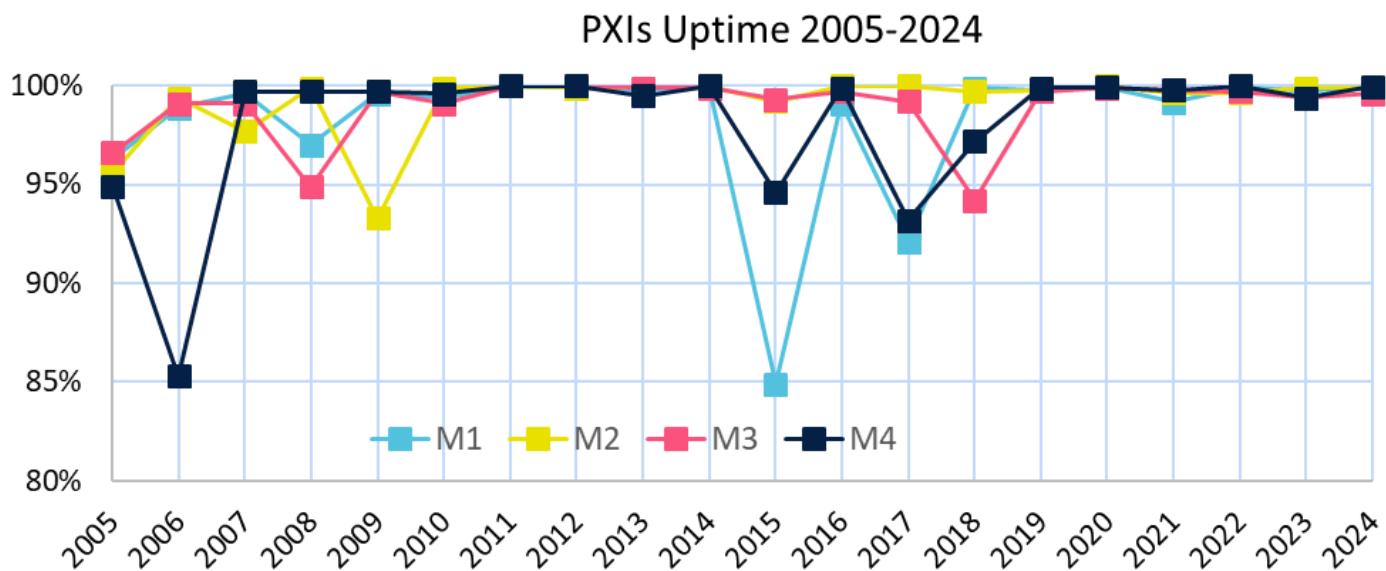
ASSET MANAGEMENT INSTRUMENTED MONITORING: SHM-OVERVIEW

Designed and installed during construction period (temporary/permanent instrumentation)

Design based on risk assessment analysis with main objectives:

- Characterization of excitation loads (Earthquake/ Wind/Traffic/Thermal)
- Measuring Bridge Response
- Design verification and feedback
- Provide real time alerts and notification based on configurable parameters
- Assist on operation/enhance user safety (black ice risk/strong winds/seismic events)

Operated since 2004 (2005-2024 average overall uptime > 98%)

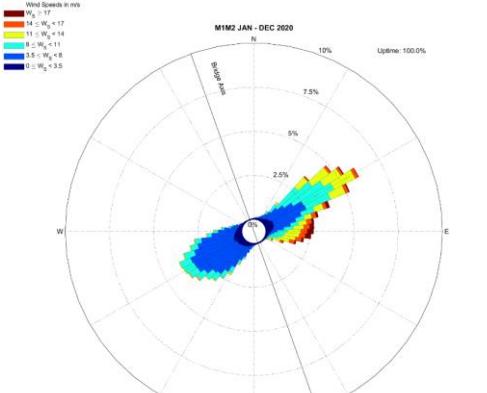
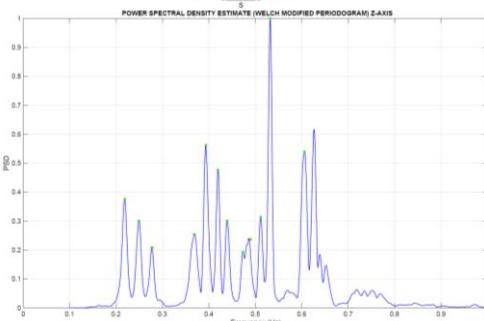
History Files analysis

- Slow varying processes/statistical parameters of structural response
- History files: 1 value every 30 sec

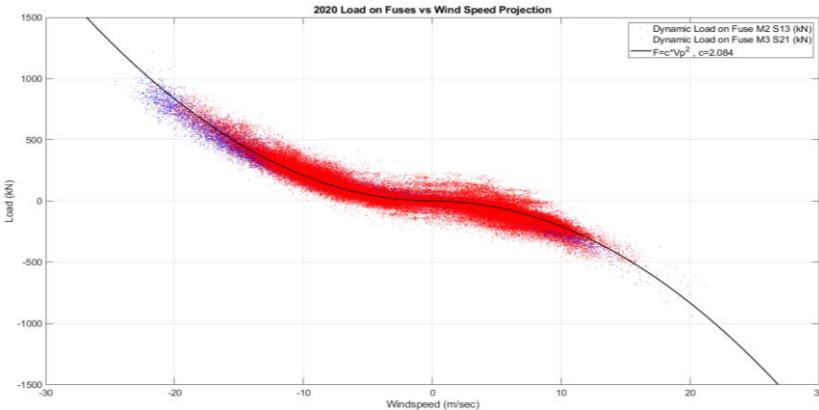
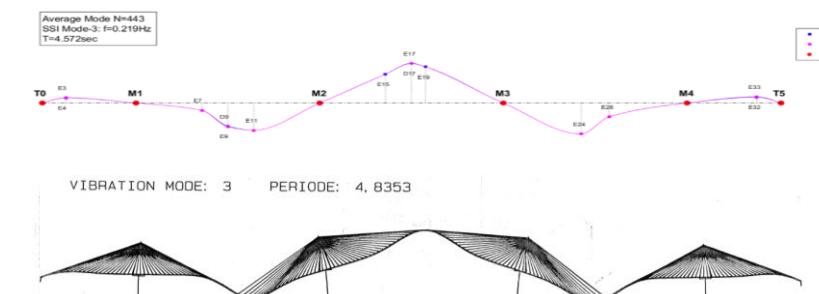
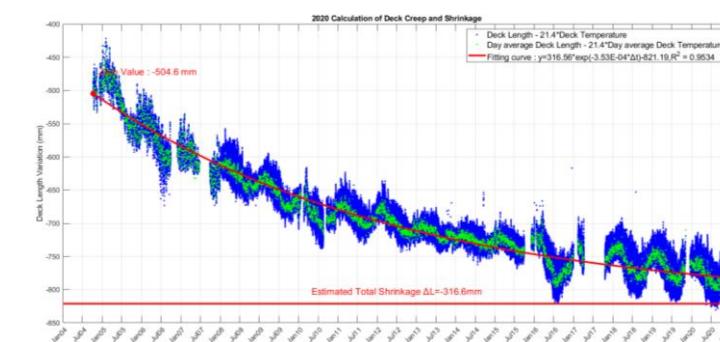
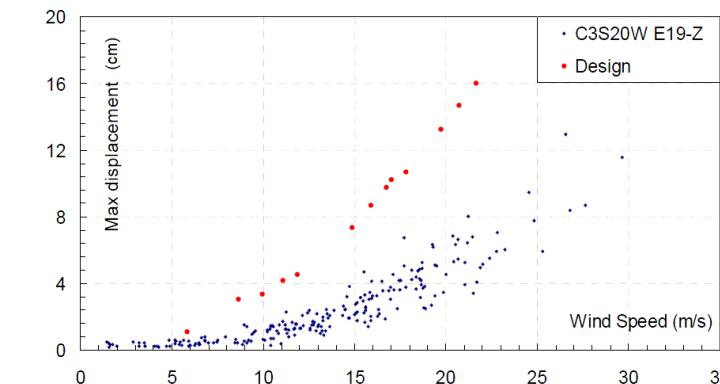
Dynamic Files Analysis

- Dynamic process/actual measurements of structural response
- Dynamic files: High frequency (100 Hz) records of limited duration (typically 3 sec)

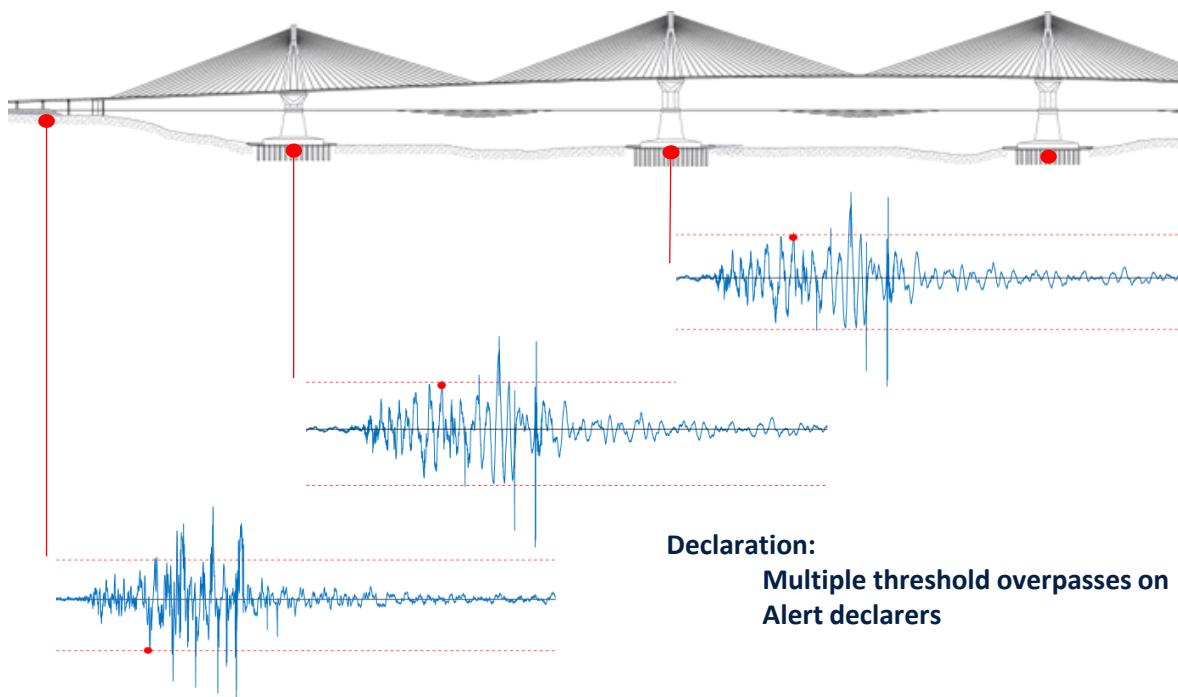
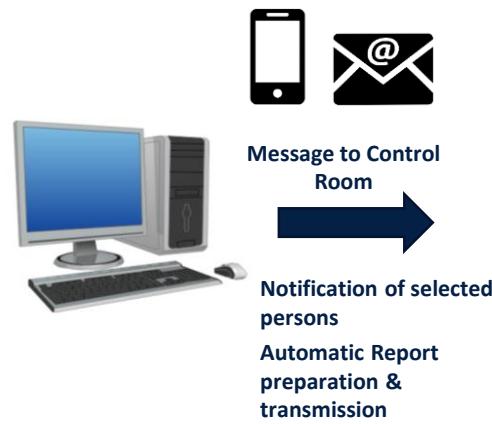
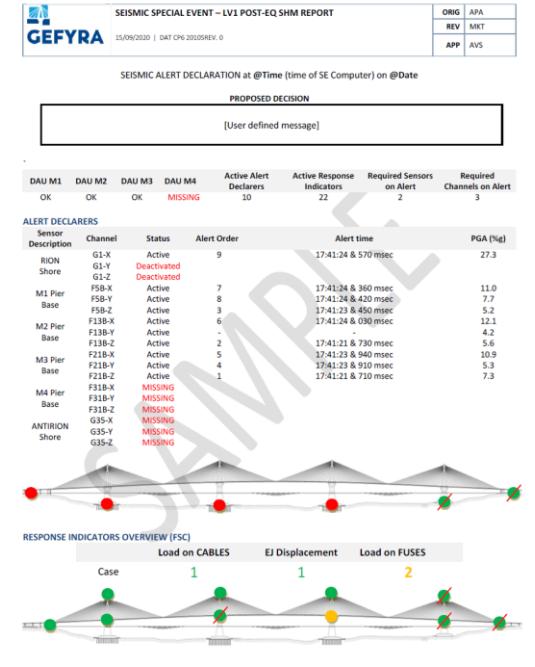
Instrumented Monitoring - Seismic event follow-up

Automated Event Management (Smart Monitoring)

1. Automated detection of earthquake events
2. Classification of structural response
3. Proposed decision on traffic management (Real time)
4. Automated report preparation and transmission

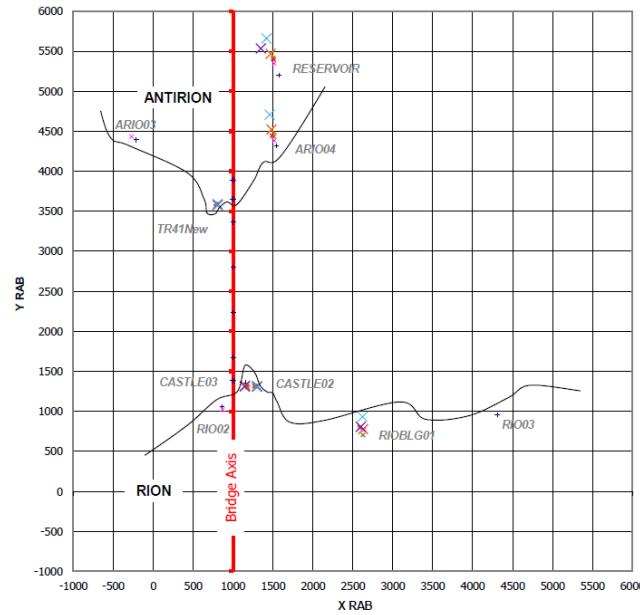
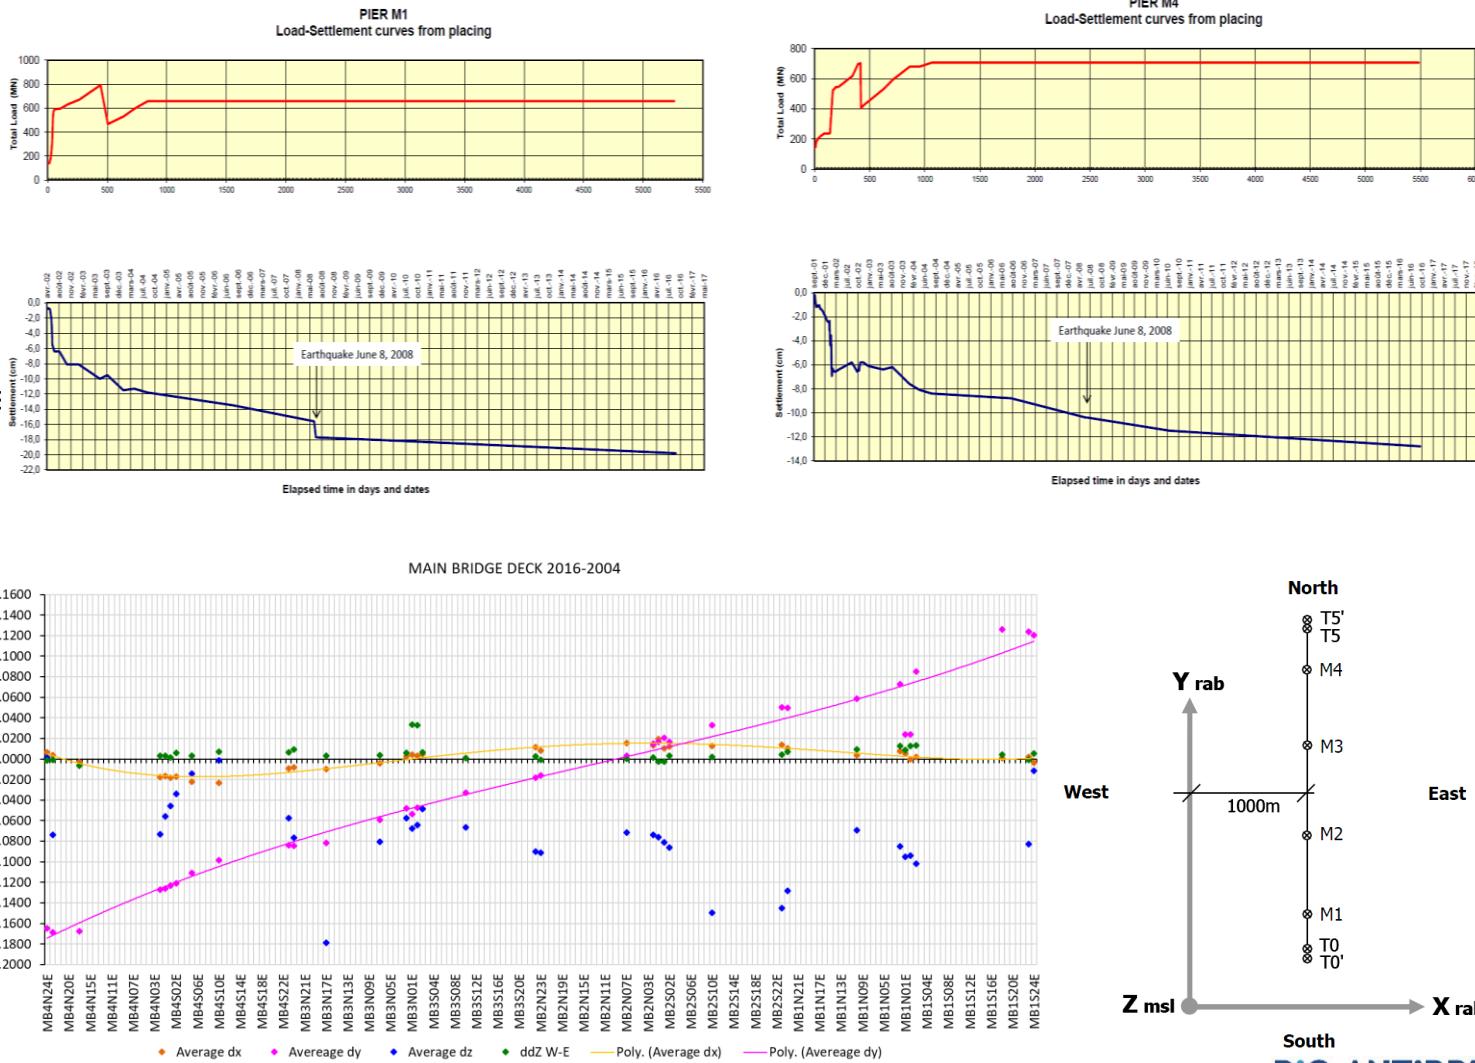
ASSET MANAGEMENT INSTRUMENTED MONITORING: GEOMETRICAL MONITORING

Measurements and evaluation of:

- Automated detection of earthquake events
- Tectonic movements
- Piers tilt & settlement
- Deck geometry
- TP settlement

The processed data are analyzed & compared with theoretical results

+ ZERO POINT 2004
 * CAMPAIGN 2006
 x CAMPAIGN 2008 Before Earthquake June 8
 r CAMPAIGN 2008 After Earthquake June 8
 o CAMPAIGN 2010
 x CAMPAIGN 2011
 + CAMPAIGN 2016

Scale for displacements :
1 square = 50 x 50 mm

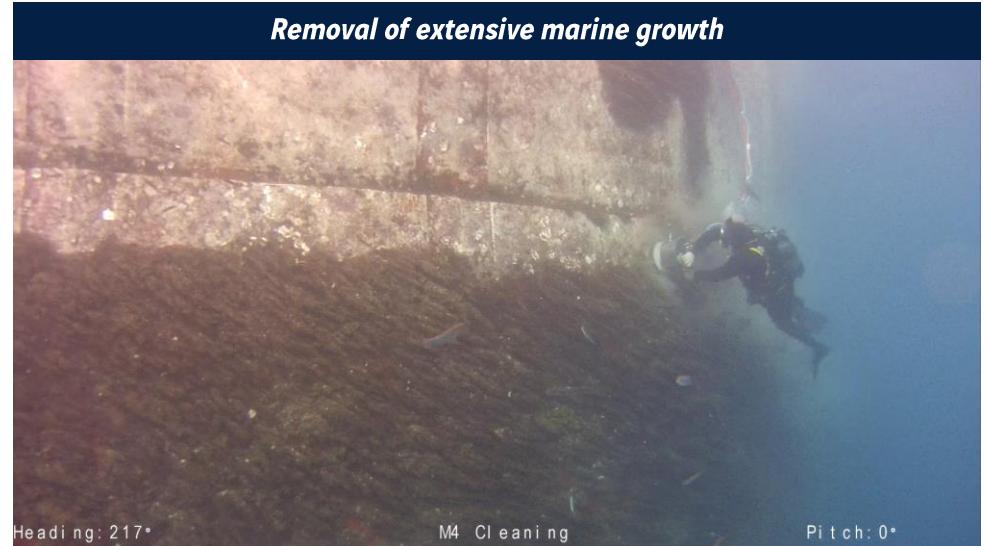
Visual Monitoring: Underwater inspections case study (1/4)

- Concrete inspections (e.g. cracks width up to 0,3mm) on the splash zone (from 0 (MSL) to -5m), being an area of 425m² per pier
- Check of Earthing System termination at sea
- Check for scouring around pier footing (perimetry of ~285m per pier)

- Removal of substantial marine growth from concrete surfaces (Splash zone)
- Weather conditions (waves)
- Strong currents
- Water depth of scour protection
- High turbidity
- Obstacles (fishing nets)

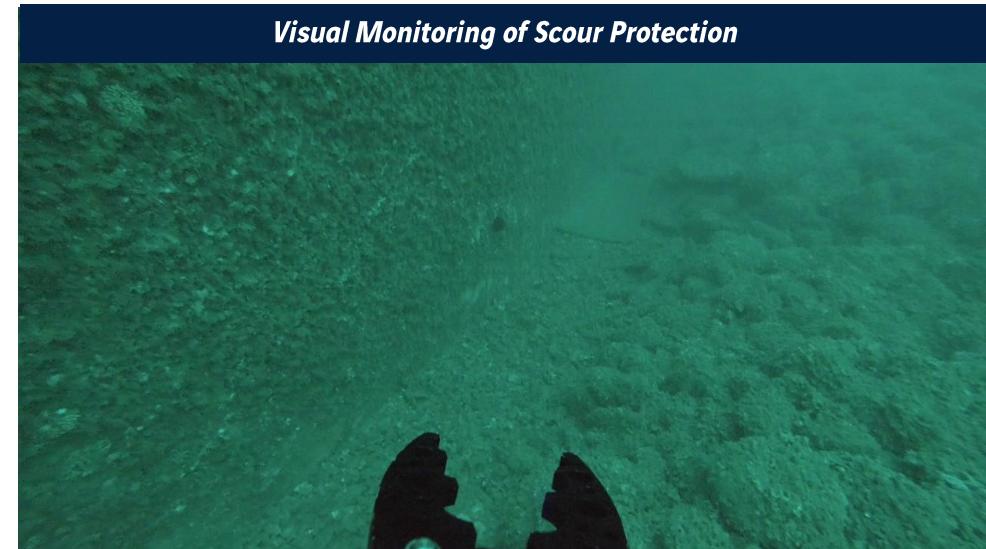
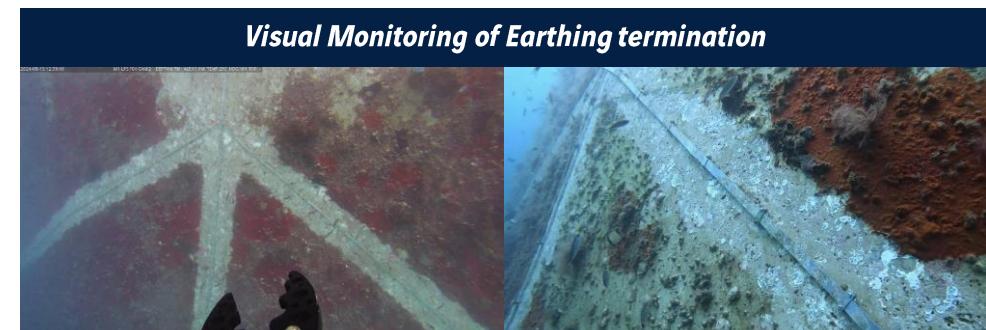
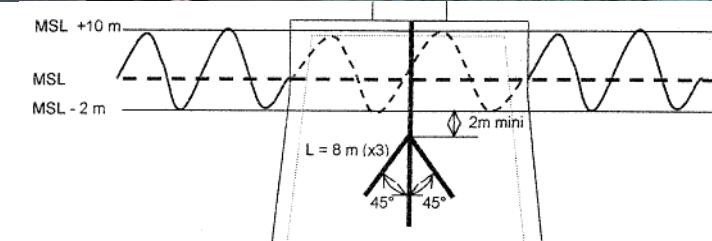
Visual Monitoring: Underwater inspections case study (2/4)

- Concrete inspections (e.g. cracks width up to 0,3mm) on the splash zone (from 0 (MSL) to -5m), being an area of 425m² per pier
- Check of Earthing System termination at sea
- Check for scouring around pier footing (perimetry of ~285m per pier)

- Removal of substantial marine growth from concrete surfaces (Splash zone)
- Weather conditions (waves)
- Strong currents
- Water depth of scour protection
- High turbidity
- Obstacles (fishing nets)

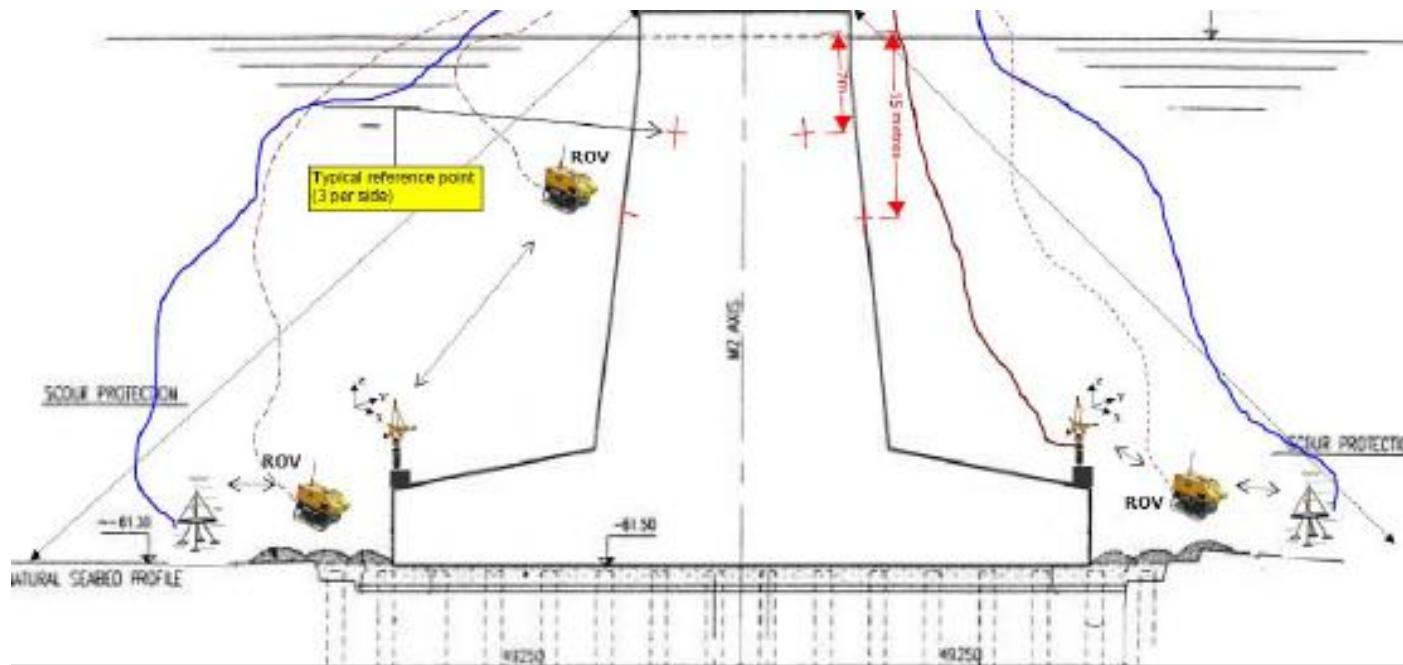
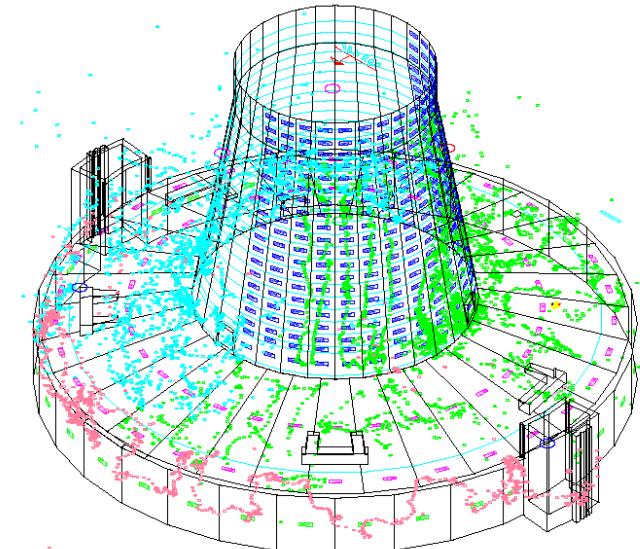
Visual Monitoring: Underwater inspections case study (3/4)

Means for Underwater Inspections in 2008

- Divers for splash and tidal zone
- ROV equipped with a local U/W positioning system based on USBL. The system was operating using specific CAD software that allowed real time position tracking.

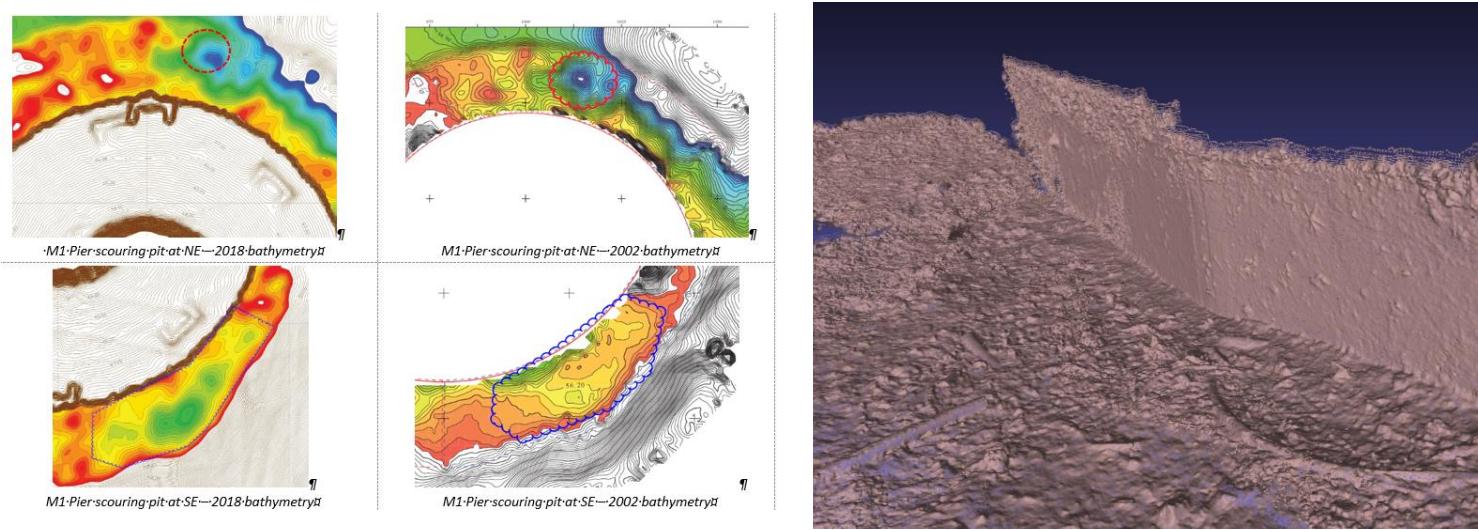
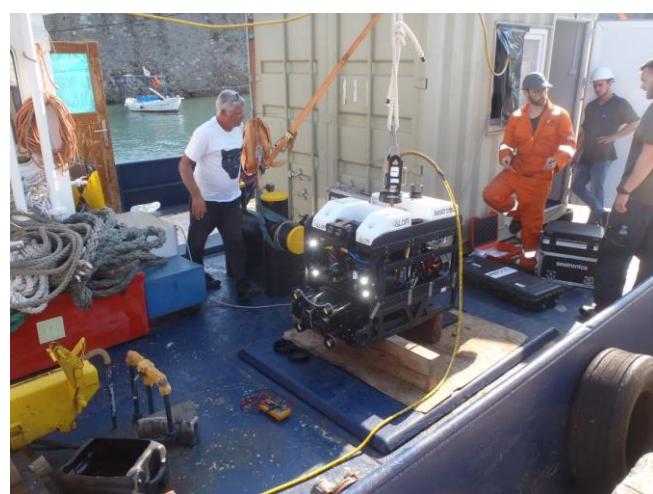
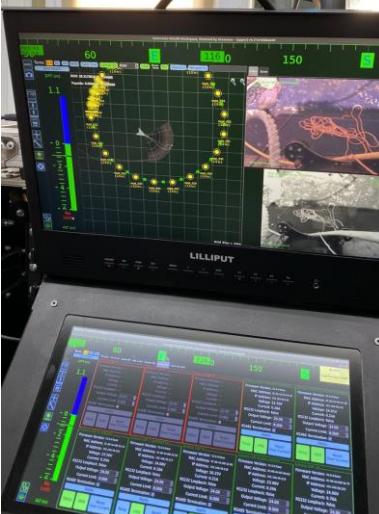
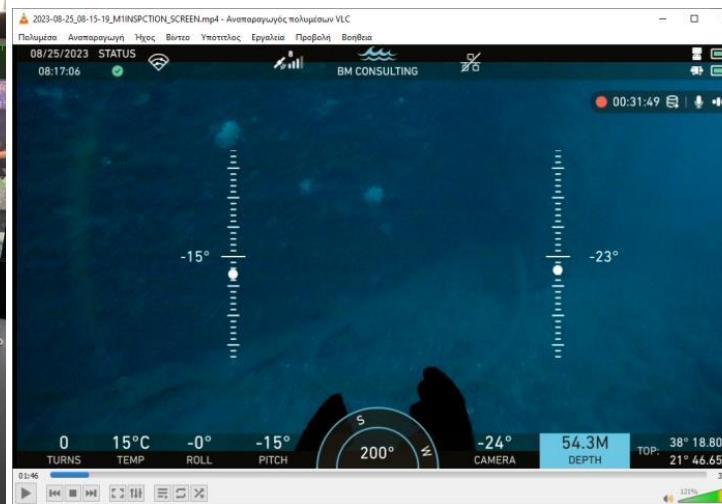
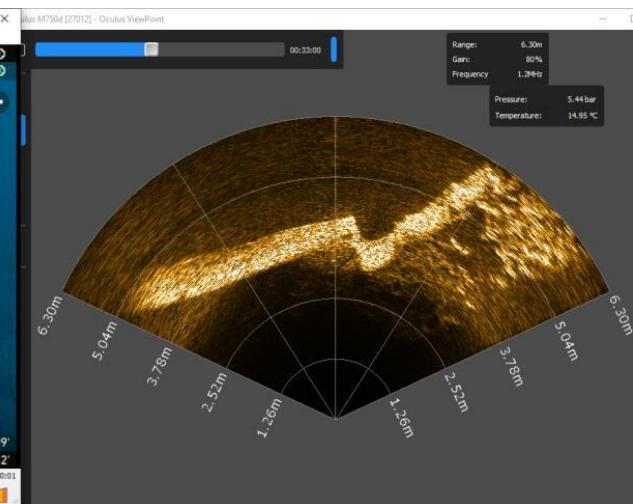
Visual Monitoring: Underwater inspections case study (4/4)

Means for Underwater Inspections in 2018-2020

- Divers for splash and tidal zone
- Multi-beam echosounder (MBES) for bathymetry survey
- Photogrammetric method for scour protection w AI driven intelligent data collection system. Real time photogrammetric model creation

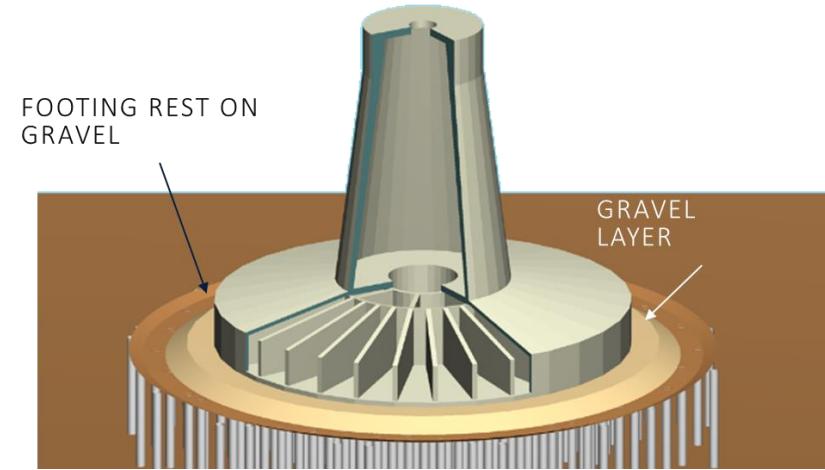
Instrumented (Geometrical) Monitoring -Offshore piers settlement case study

- Tectonic movements
- **Piers tilt & settlement**
- Deck geometry

The processed data are analyzed & compared with theoretical results

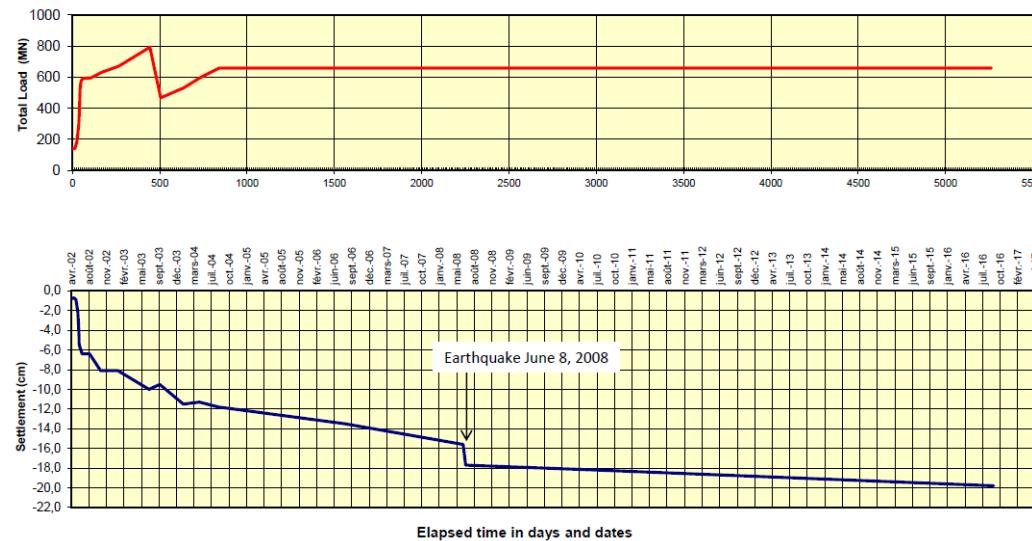
PIER M1
Load-Settlement curves from placing

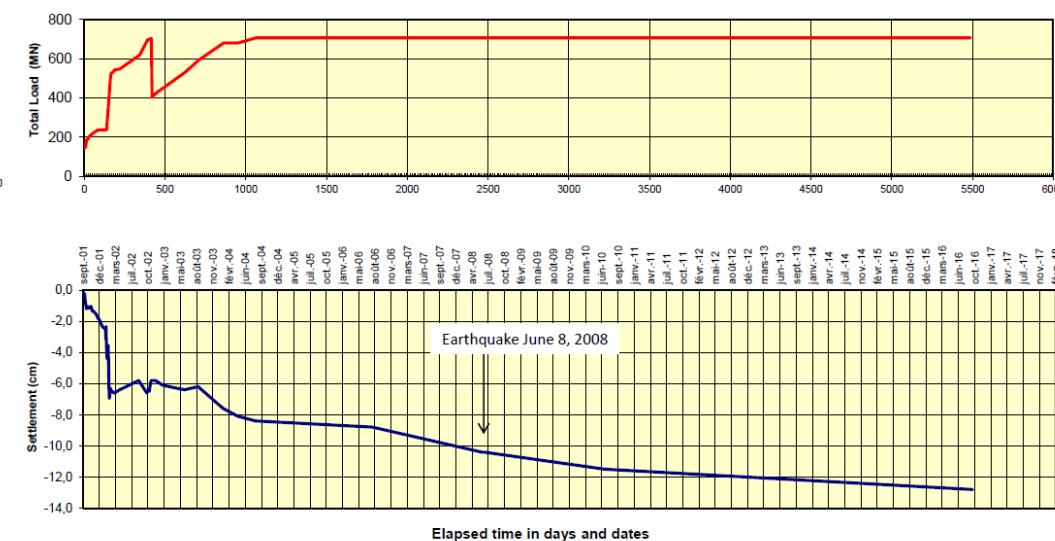
PIER M4
Load-Settlement curves from placing

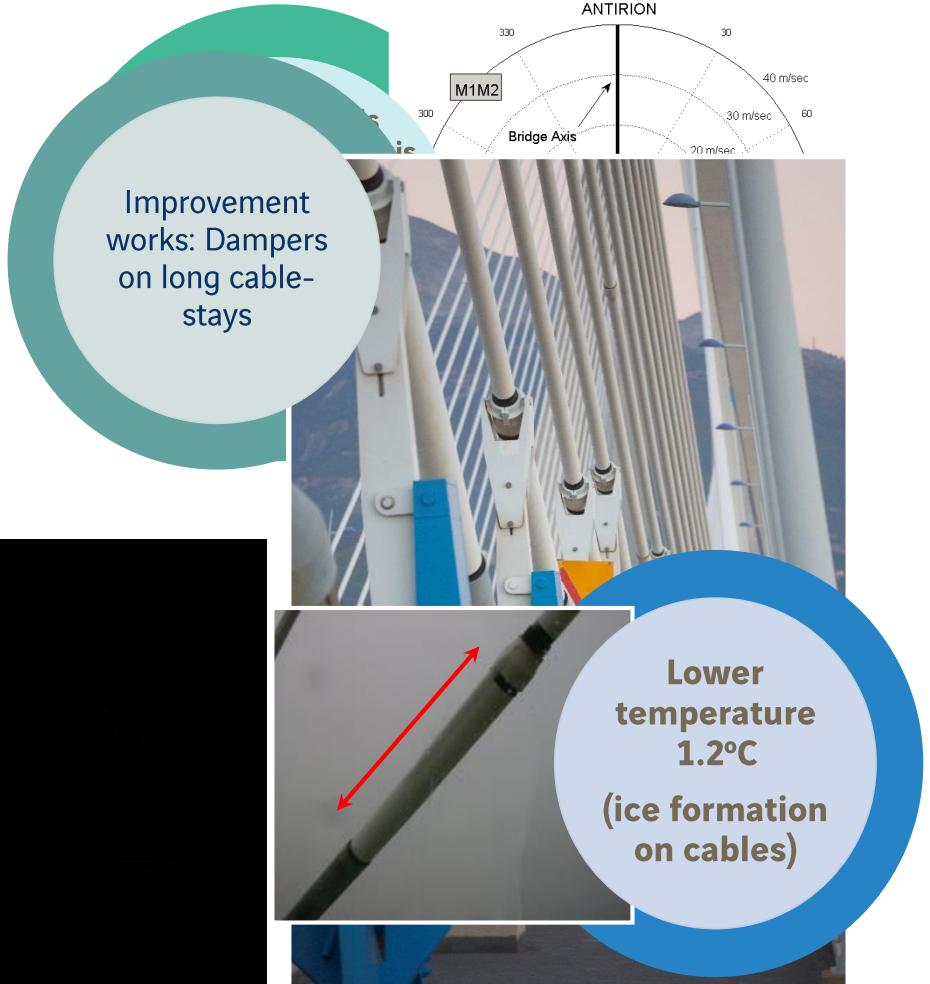
SPECIAL EVENT: WIND STORM JAN 23, 2006

● ● ● Evaluation of Bridge response (Strong wind event)

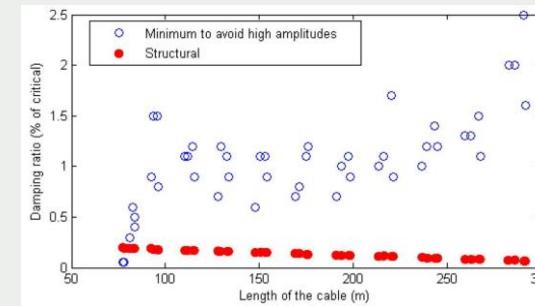
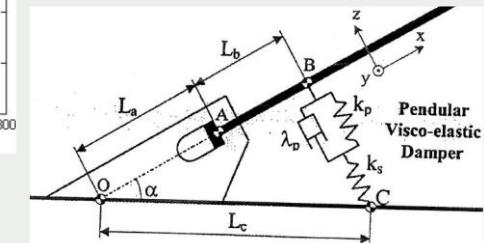
● ● ● Analysis of actual data for required additional damping (CSTB)

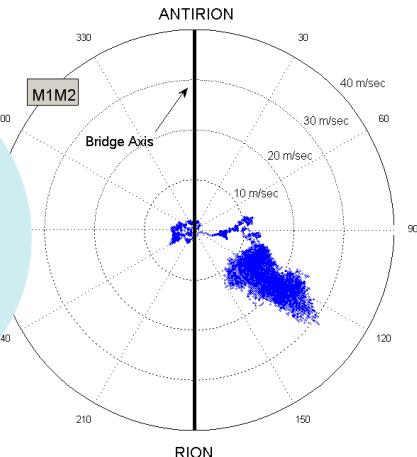
Eastern winds
0° from deck axis
maximum wind
speed
(10' average)
m/sec M1M2
m/sec M3M4

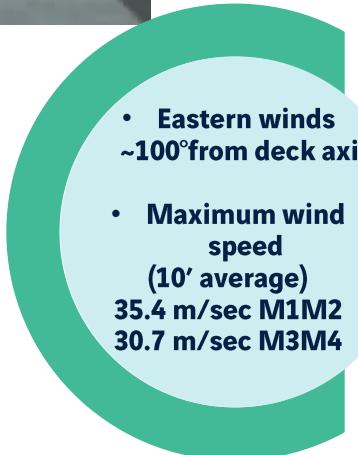
MAR 08, 2010

- Eastern winds
~100° from deck axis
- Maximum wind
speed
(10' average)
35.4 m/sec M1M2
30.7 m/sec M3M4

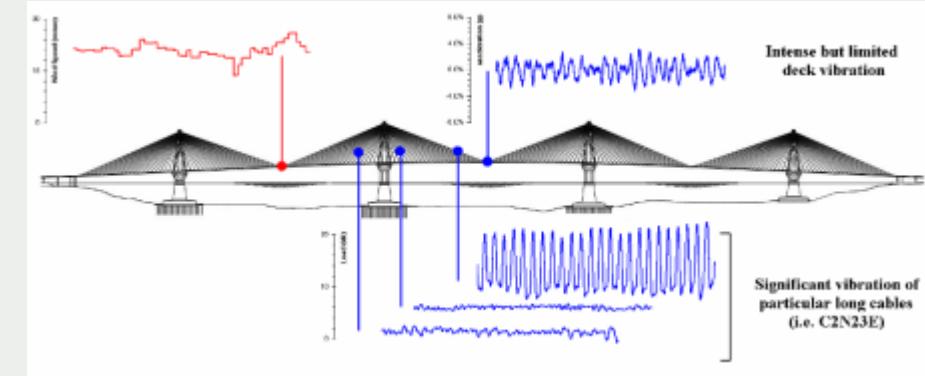
● ● ● Evaluation of Bridge response (Strong wind event)

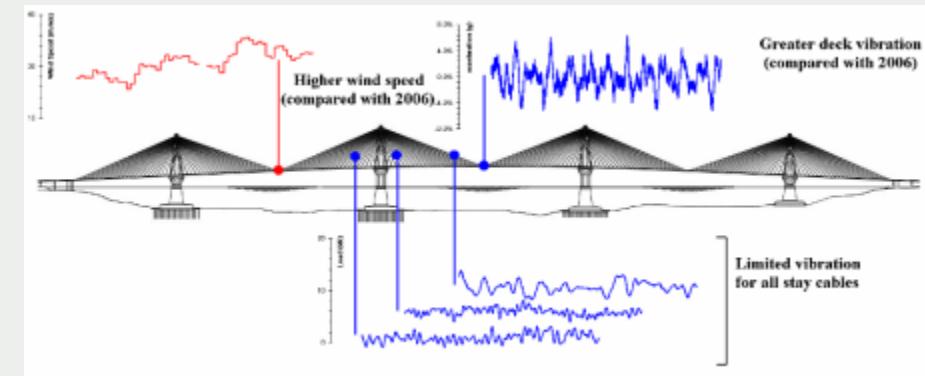
● ● ● Evaluation of Bridge response (after improvement works)
