ΓΕΦΥΡΑ ΡΙΟΥ-ΑΝΤΙΡΡΙΟΥ «ΧΑΡΙΛΑΟΣ ΤΡΙΚΟΥΠΗΣ»

Καινοτόμες Μέθοδοι Παρακολούθησης &
Συντήρησης Ειδικών Γεφυρών
Η Περίπτωση της Γέφυρας Ρίου-Αντιρρίου
«Χαρίλαος Τρικούπης»

Innovative Monitoring and Maintenance of
Major Bridges
The Rion-Antirion Bridge “Charilaos
Trikoupis” Case Study

RION – ANTIRION BRIDGE PROJECT DESCRIPTION (1/5)

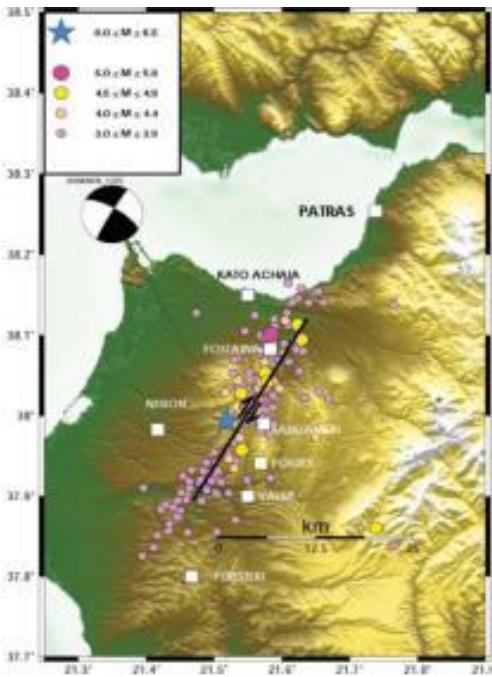
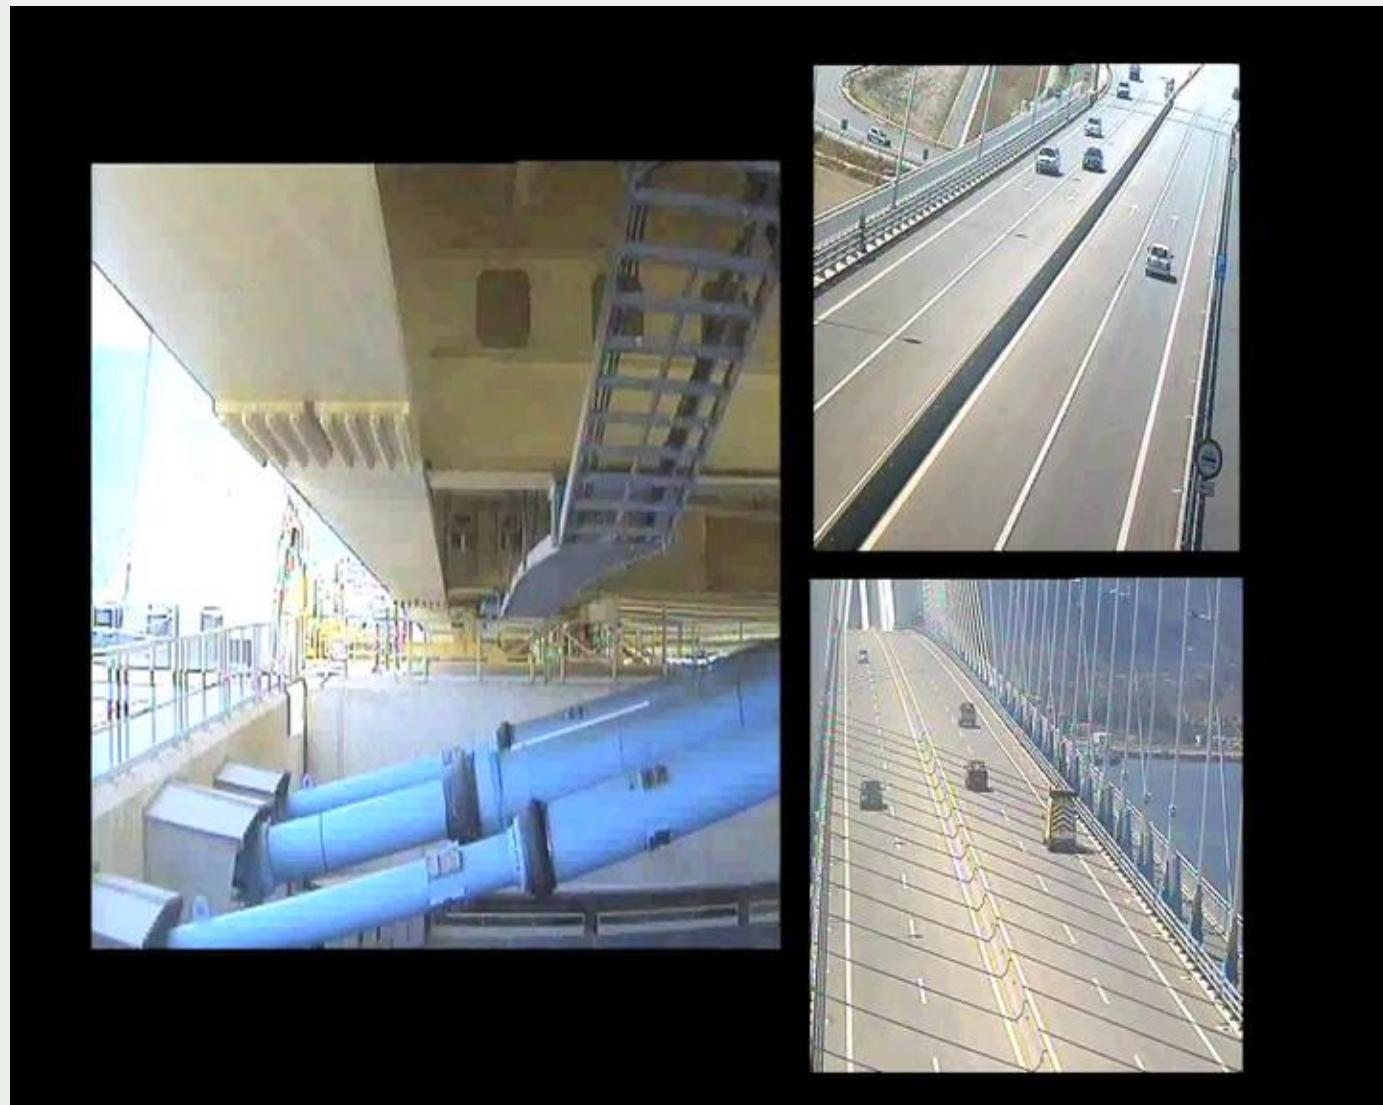
SPECIAL EVENT: EARTHQUAKE JUN 08, 2008

- Magnitude $M_w=6.4$
- 36km from Rion-Antirion site.
- Focal depth:31km
- Max PGA recorded from on-shore accelerometers:0.127g (at Rion bank)

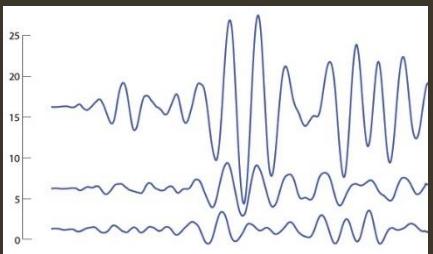
Monitoring Report

First review of monitoring data recorded
SLS was not exceeded
Indication of deck release (fuses)

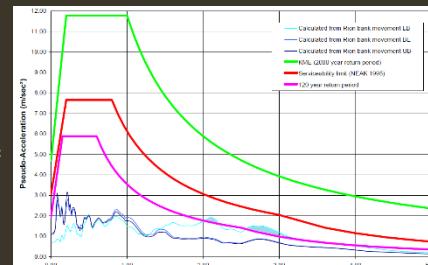
Analysis of Monitoring data

Expertise analysis on collected data

Evaluation of similar EQ's return period
T= 80 to 120 years

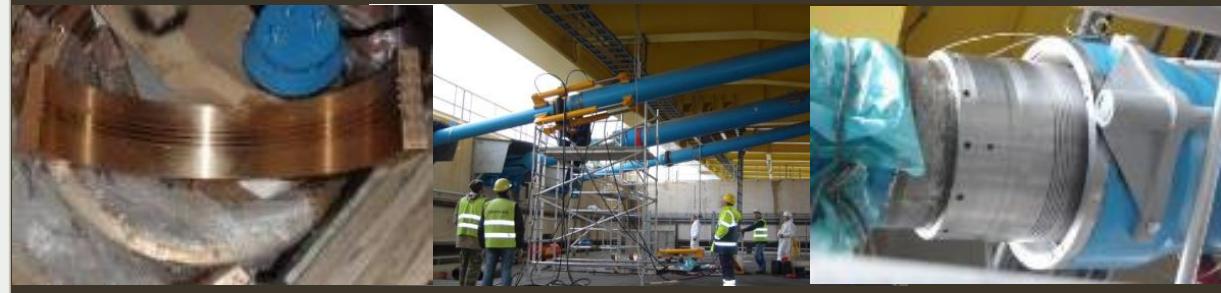
Deck re-alignment and fuse replacement
